**United States
Department of the Interior**

**Aviation Safety Review
Fiscal Year 00**

**Prepared by
Office of Aircraft Services
Aviation Safety Office
June, 2001**

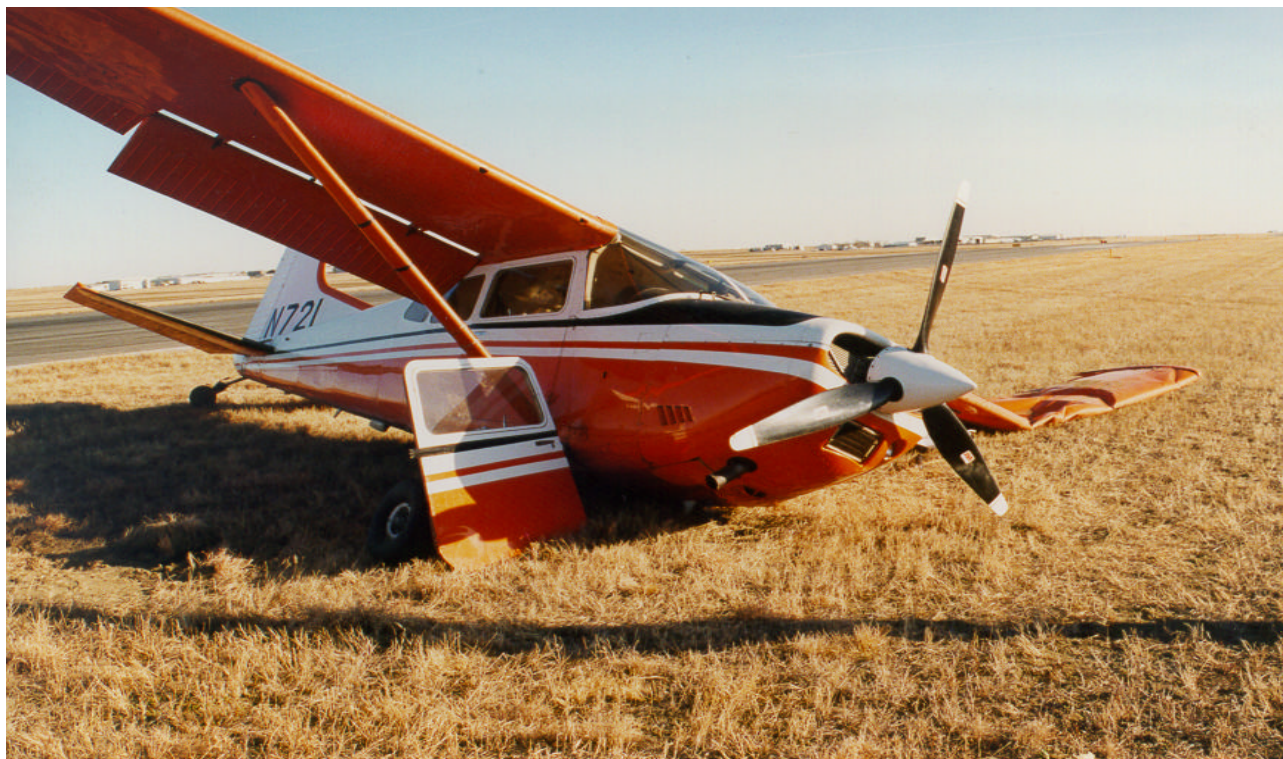
**AIRCRAFT ACCIDENT
00-0F01-O-FWS**

Narrative: On February 7, 2000, approximately 1215 Mountain Standard Time, a Cessna 185F, N721, owned and operated by the U.S. Department of the Interior, was substantially damaged when it collided with terrain while landing at the Fort Collins/Loveland Municipal Airport, Loveland, Colorado. The commercial certificated first pilot received minor injuries and the commercial certificated flight instructor was not injured. Visual meteorological conditions prevailed for the public use instructional flight, and a company VFR flight plan had been filed. The flight originated at Broomfield, Colorado approximately 1030. According to the accident report submitted, the flight instructor, seated in the right seat, had been giving the commercial (first) pilot, seated in the left seat, a biennial flight review (BFR) to satisfy the requirements of FAR (Federal Aviation Regulation) 61.56(c). At the conclusion of the BFR, it was agreed that the flight instructor would make a full stop landing (it was later learned the instructor was not current in aircraft category and class). A normal approach to runway 15 was flown in a "moderate" right crosswind (5 to 10 knot, variable). A full stall landing was made with a slight crab into the crosswind. The tail wheel touched down first, followed by the main gear. The airplane then veered right and ground looped. The left main landing gear collapsed, and the airplane came to a halt off the right side of runway 15.

The flight plan filed was not in accordance with OPM 00-2

Flight following was not in accordance with OPM 00-2.

The flight instructor was operating flight controls without authorization required by 351 DM 1.2B.

Pilot-in-command did not know the flight instructor was not current in either tail wheel aircraft or this model of aircraft.

The aircraft was equipped with diagonal single-strap shoulder harnesses. Side loads during the accident allowed the pilots to slide out of the shoulder harnesses.

Aircraft was over due a 100-hour inspection.

Both pilots were not wearing helmets. (Helmets are not required by DOI policy).

The pilot in command was not designated for this mission in accordance with 351 DM 3.1B.

Probable Cause: The National Transportation Safety Board determines that the probable cause of this accident was the failure of the pilot-in-command to maintain directional control, resulting in an inadvertent ground loop.

Contributing Factors: A factor was the crosswind.

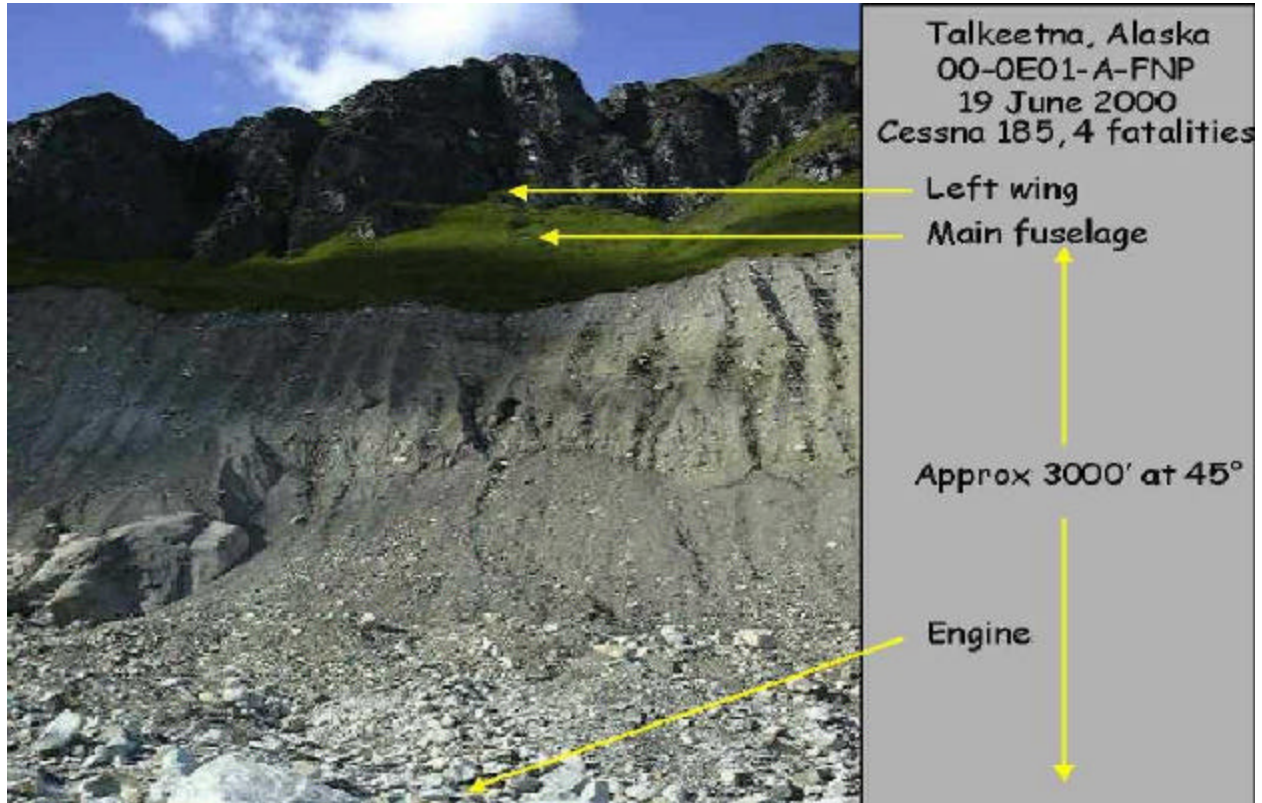
AIRCRAFT ACCIDENT
00-0E01-A-FNP

Narrative: On June 19, 2000, about 1815 Alaska Daylight Time, a wheel/ski equipped Cessna 185E airplane, N1589F, was destroyed when it crashed in a remote area of the Denali National Park and Preserve, about 52 miles west of Talkeetna, Alaska, at latitude 62 degrees, 42.489 minutes north, and longitude 151 degrees, 45.385 minutes west. The airplane was being operated as a visual flight rules (VFR) U.S. Government flight by the U.S. Department of the Interior, National Park Service, Talkeetna, Alaska, when the accident occurred. The airplane, provided by Hudson Air Service Inc., Talkeetna, was utilized as an on-demand Title 14 CFR Part 135 flight. The airline transport certificated pilot, and the three passengers received fatal injuries. A VFR flight plan was filed. The flight was conducted to transport a National Park Service ranger, and two volunteer rangers to the Denali National Park base camp, located at 7,200 feet msl on the Kahiltna glacier, about 48 miles northwest of Talkeetna. The three rangers were to begin mountain patrol operations on Mt. McKinley. The closest official weather observation station is Talkeetna. At 1757, one ranger aboard the airplane contacted the Talkeetna Ranger Station by radio and stated the flight was returning to Talkeetna. About 1800, the pilot contacted an air taxi pilot on the ground at the base camp, and reported that weather conditions had closed in over the

Pilot encountered unanticipated adverse weather enroute to Denali Base Camp. Post accident investigation found no evidence that the pilot received a weather briefing for this flight.

No reports of an emergency ELT signal from the accident aircraft.

At the accident site the recording hour meter in the airplane's tachometer indicated the aircraft had flown 11.9 hours beyond the next required inspection time.

Flap handle control was found in the second notch (20 degrees of flap). The aircraft Operator's Manual indicates a significant reduction in structural strength with the flaps extended.

Radio communications have been reported as marginal between Talkeetna and base camp. Reliable radio communications along this route could improve flight safety by allowing weather reports to be readily transmitted between base camp and transiting aircraft.

Contract pilots and organizations would benefit from, but generally do not participate in, DOI-conducted briefings, such as: mishap reviews, hazard reporting procedures, and safety policies.

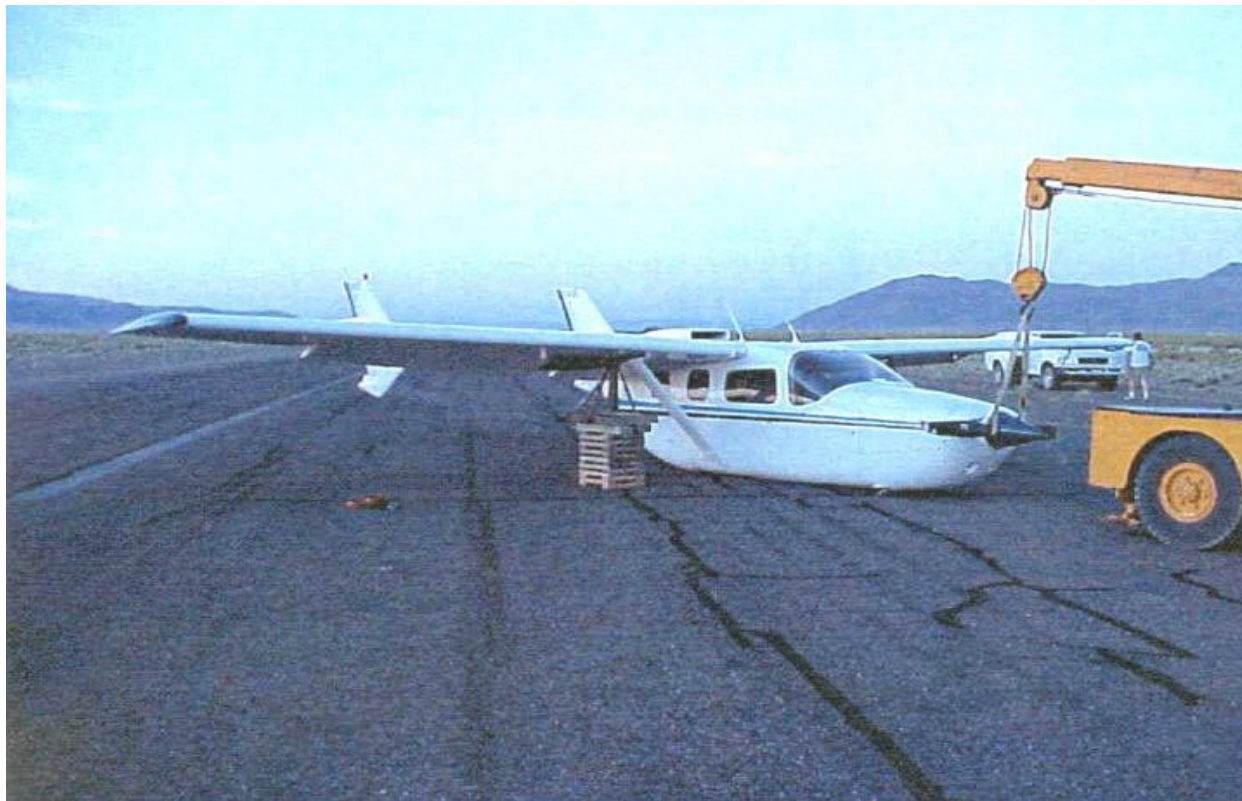
AIRCRAFT ACCIDENT
00-0F02-A-LLM

Narrative: On July 12, 2000, at 1845 hours Pacific Daylight Time, a Cessna 337G, N3273D, landed gear up at the Battle Mountain, Nevada, airport. The airplane was operated by the U.S. Department of the Interior, as a public-use airplane under 14 CFR Part 91, and sustained substantial damage. The commercial pilot and one passenger were not injured. Visual meteorological conditions existed for the cross-country flight that had departed the Boise, Idaho, airport at an unknown time, and was scheduled to terminate at Battle Mountain. A company Visual Flight Rules (VFR) flight plan had been filed. In an interview with a Federal Aviation Administration inspector, the pilot stated that he forgot to put the landing gear down. He indicated that because he had kept his airspeed up during the descent, the landing gear warning horn did not activate. He had flown the airplane earlier that day from Battle Mountain to Boise to exchange firefighting crews, and no discrepancies were noted with the landing gear system.

Pilot-in-command did not use a checklist and forgot to lower the landing gear.

The landing gear warning horn, transmitting from the airplane's cabin speaker and not the intercom system, was difficult to hear when wearing a headset. The landing gear warning horn was similar in volume and tone to the stall warning horn.

The pilot reported that he did not ask his passenger for assistance with CRM-safety of flight issues such as watching for traffic or reading the checklist.

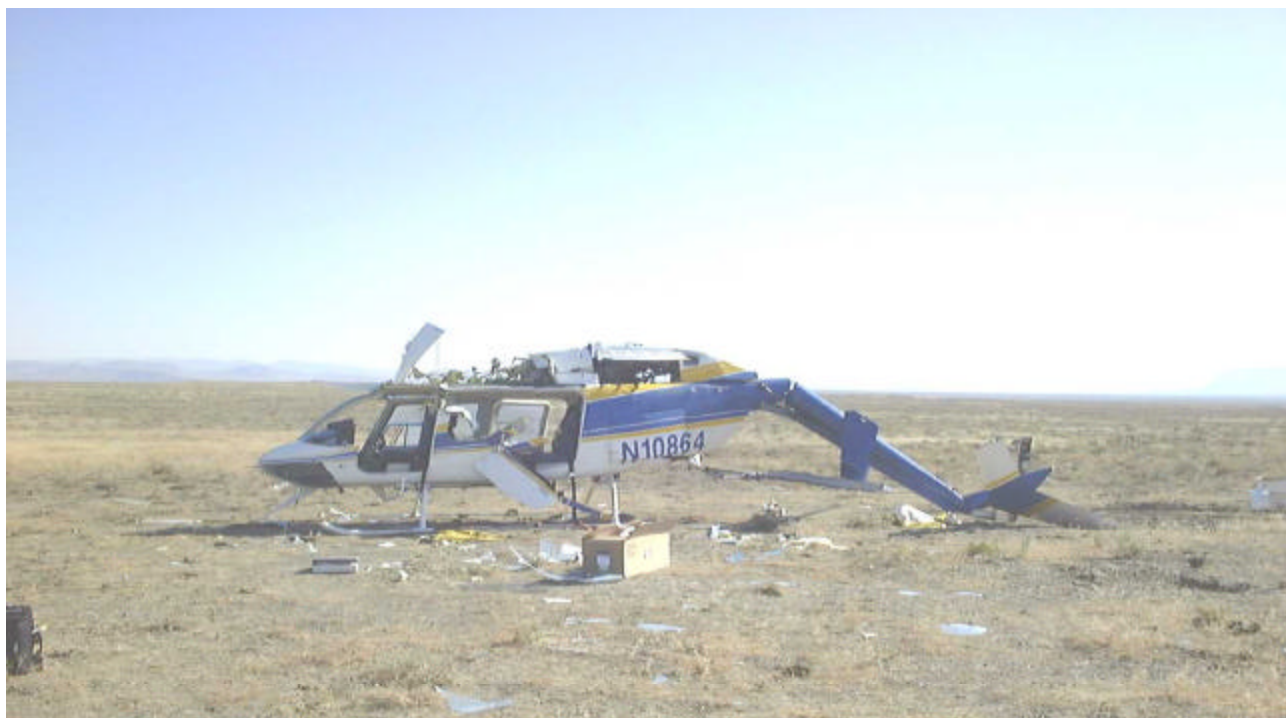
AIRCRAFT ACCIDENT
00-0F03-C-LLM

Narrative: On August 3, 2000, at 1855 hours Pacific Daylight Time, a Bell 206L-1, N10864, was destroyed when the helicopter abruptly rolled to the right and impacted terrain during hover after takeoff at Montello, Nevada. The helicopter was operated under 14 CFR Part 91 in support of firefighting activities as a public-use aircraft by the United States Bureau of Land Management. One passenger was fatally injured and the other passenger was seriously injured. The commercial certificated pilot was not injured. Visual meteorological conditions prevailed and no flight plan was filed for the positioning flight that was destined for Wells, Nevada. There were six ground-based crewmembers affiliated with the operation of the helicopter that witnessed the accident. All of the witnesses were together as a group about 50 feet south of the departing helicopter. The witnesses provided a consistent opinion that the helicopter was clear of the ground, in a stable hover at 2 to 5 feet above the ground, when it suddenly rolled to the right and crashed. Two witnesses described the rolling maneuver as "hard" and "violent." There was some disagreement about whether the helicopter rolled to the right until inverted and then bounced back to the left back up on its skids, versus rolling to the right one complete revolution to end up upright. Some commented that the flying dirt and debris from the helicopter was confusing. None of the witnesses described the maneuver as a yawing or spinning maneuver, but rather as a roll about the longitudinal axis. The pilot reported that between 1500 and 1830 there was a windstorm with wind gusts of 50 - 60 knots associated with a thunderstorm that passed west of their location. He tied down the main and tail rotor blades before the

windstorm, and by 1845, the weather was clear enough to return to Wells and the wind had decreased to 5 - 10 knots. He preflighted the helicopter and untied the rotors. He said that the start and pretakeoff checks were normal. He performed a normal hydraulics-off control check. He "picked the helicopter up" to a 3-foot hover height and glanced down at the engine torque gauge. Suddenly, the helicopter did a "violent snap roll" to the right coming to rest upright. He estimated the whole event only lasted about 1/4 second. The pilot added that there was no yaw associated with the event, it was pure roll, and the engine operated "fine" the entire time. The engine was still running after the accident and he had to shut it off manually. There was no change in audible tone prior to the roll. He did not recall any movement or abnormal feedback in the antitorque pedals or the cyclic and collective controls prior to the accident. The pilot emphasized the violent nature of the roll. It was the pilot's opinion that even an abrupt, full right cyclic input could not have produced the rate of roll he experienced. The rotor blade tie-down retention straps were found stowed inside the cabin after the accident.

Use of flight helmets saved one life.
Dual shoulder harness restraint system.

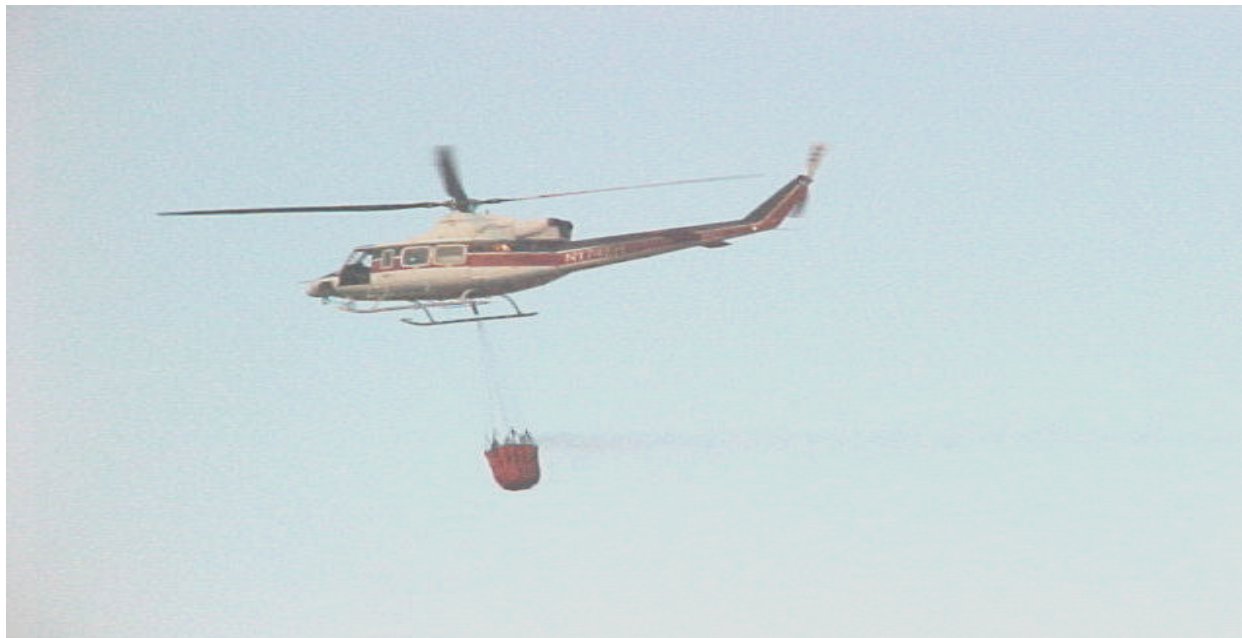
**AIRCRAFT ACCIDENT
00-0F04-C-LLM**

Narrative: On August 13, 2000, at 1646 hours Pacific Daylight Time, a Bell 412, N174EH, collided with mountainous terrain while conducting a water drop on a wildfire along a ridgeline near Cold Springs, Nevada. The helicopter was operated by the Bureau of Land Management as a public-use firefighting mission under the provisions of 14 CFR Part 91, and was destroyed. The airline transport pilot sustained fatal injuries. Visual meteorological conditions prevailed for the accident flight, and a company flight plan was filed. The helicopter had departed the Twin Peaks Helibase located at Cold Springs at 1605. Weather reported by another firefighting pilot who was flying in the area at the time of the accident was about 79 degrees Fahrenheit, with winds from the north-northwest at 10-15 knots. The accident site elevation was about 6,300 feet msl. An approximate density altitude of 9,100 feet was calculated for the accident location. The accident helicopter was the lead in a flight of two helicopters that was to make a bambi bucket water drop along the ridgeline, at his discretion, with the trailing pilot also making a water drop behind the accident helicopter. After takeoff from the helibase the helicopters traveled in a northeast direction to the ridgeline, and the lead pilot had made his turn and was paralleling the ridgeline. The trailing pilot, who was about 1 mile behind, saw the accident helicopter make a sudden 90-degree left (descending) turn and impact the downsloping mountainous terrain shortly thereafter. There were no radio communications with the accident pilot prior to the turn. The trailing pilot estimated the airspeed during the approach to the ridgeline to be about 20 knots. The accident site

was located on the side of a mountain with approximately a 60-degree slope facing south towards the helibase. Pinion trees and scrub brush sparsely covered the mountainside, with loose dirt and rocks typical of high desert terrain. A path of ground scars and wreckage debris was observed distributed over a 673-foot distance on a median magnetic bearing of 155 degrees. The first observed point of contact was approximately 300-feet upslope from the main wreckage and consisted of water erosion furrows which emanated from a circular impression centered on an unburnt bush. The hook for the bambi bucket was found 90-feet from the first observed point of contact. The release mechanism and the bambi bucket were located 2 feet beyond the hook, entangled in a dead pinion tree. The bambi bucket was on a short line approximately 25 feet long. The skid toes were found in the dirt about 25 feet from the pinion tree and entangled bucket. The cross tubes were found attached to the main fuselage. Separated skid tube components were scattered along the wreckage path at various locations. Six inches of one tail rotor blade was separated from the tail rotor and found approximately 50 feet to the right side of the first observed point of contact looking down slope towards the main wreckage. The aft portion of the tail boom structure was found about 10 feet from the main wreckage and the forward portion of the tail boom structure was found approximately 65 feet from the main wreckage. All four main rotor blades were found attached to the hub, with the outboard 6 inches of one blade found approximately 20 feet from the main wreckage in the debris field. Visual examination of the No. 1 engine (left) showed that multiple blades were separated from the power turbine wheel. The blade separations were jagged and of irregular length compared to one another. Evidence of indentations were observed inside the exhaust stack. No filament stretch was observed on any of the caution/warning lights.

<u>Key Issues</u>	<u>Discussion</u>
<ul style="list-style-type: none"> • Pilot repeatedly took excessive and unnecessary risk 	<p>Helicopter</p> <p>Managers</p>
<ul style="list-style-type: none"> • Training 	<p>Regularly provide training for contract pilots and personnel.</p>
<ul style="list-style-type: none"> • Utilization of appropriate aircraft 	<p>Dispatching Officials</p>
<ul style="list-style-type: none"> • DOI Safecom System 	<p>Review/re-evaluate the DOI Safecom system</p>
<ul style="list-style-type: none"> • Contract Language 	<p>Clarification of DOI Exclusive-Use Contract language concerning bucket operations and aircraft performance.</p>
